In-Field Observations of Heavy Mining Vehicle Wheels and Analyses of Proposed Solutions to Enhance Safety

A Thesis
Submitted to the Faculty of Graduate Studies
through the Department of Mechanical, Automotive, and Materials Engineering
in Partial Fulfillment of the Requirements for
the Degree of Master of Applied Science
at the University of Windsor

A safety shield system was proposed. Effectiveness of the design was examined through numerical simulation of the ISO 7141 impact test, a tire blowout, and a rotational side impact. Depending on the test condition, observations comparing shield-equipped versus standard wheels show reductions in von Mises stress between 15% and 55% and reductions in effective plastic strains between 20.3% and 92%.

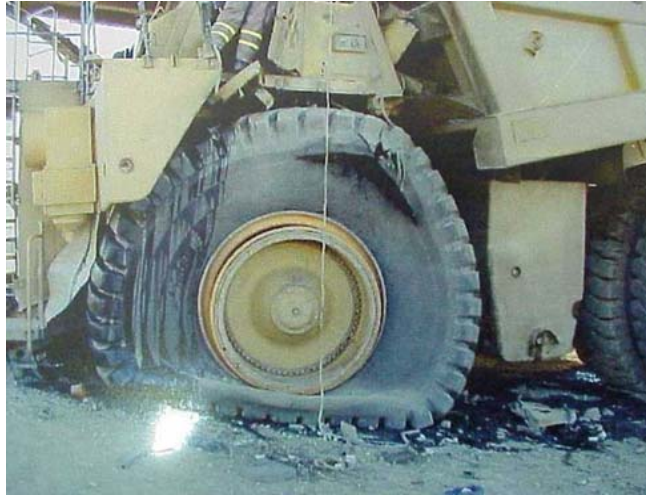
Figure 2.3.1 – Result of tire zipper failure [21].

to adjacent body plies until all pressure is evacuated. The origin for the name of this type of failure is due to the post-failure appearance of the ruptured area where typically an even line of broken steel cords are exposed. This is shown in Figure 2.3.1 below.

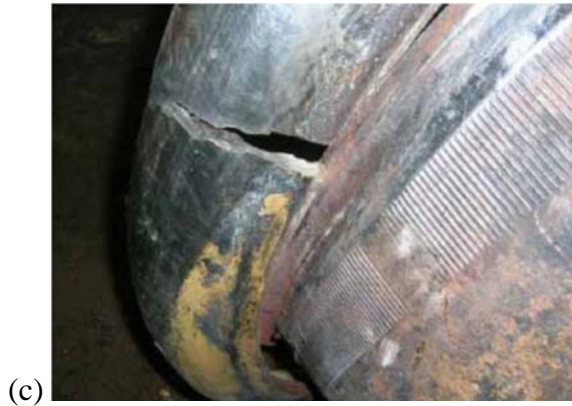
Figure 2.3.2 - Photos of failed wheels illustrating (a) tire damage due to flange separation, (b) rim base wear and fatigue crack, and (c) a cracked outer flange [21].

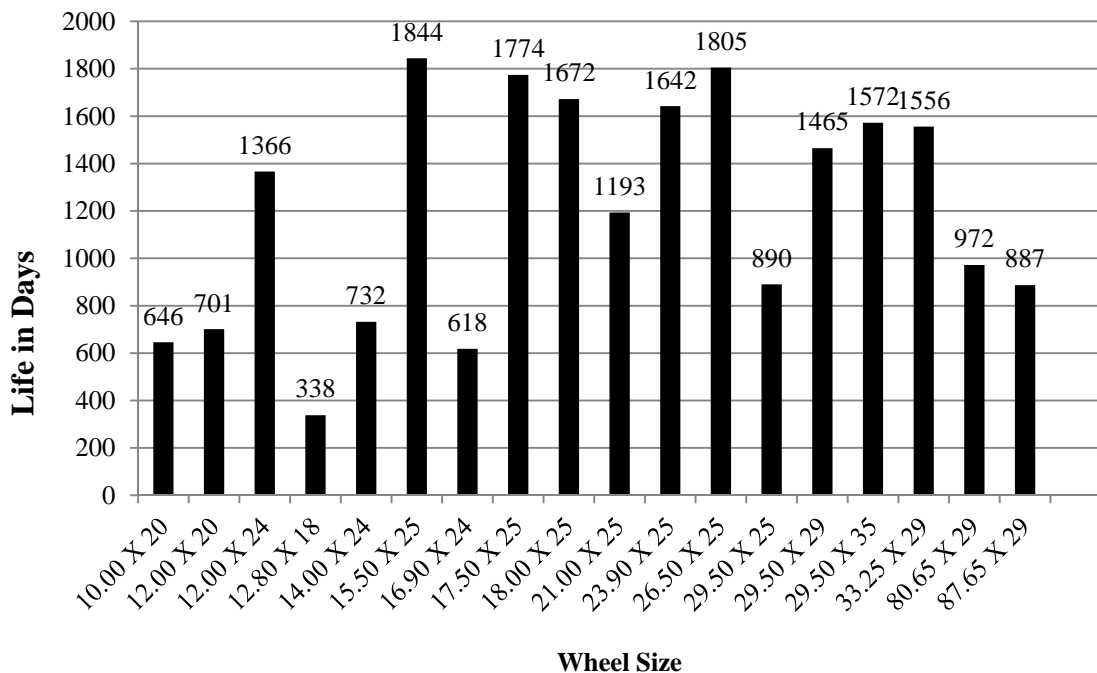
Figure 5.3.2 - Average wheel life (by size) as calculated by database.
